Project Silent Anzac
Maritime Archaeological Assessment 2014
Interim Report

1. Project Silent Anzac is being undertaken by the AE2 Commemorative Foundation (AE2CF) Ltd, established by the Submarine Institute of Australia to protect, preserve and tell the story of the World War I Australian submarine, HMAS AE2.

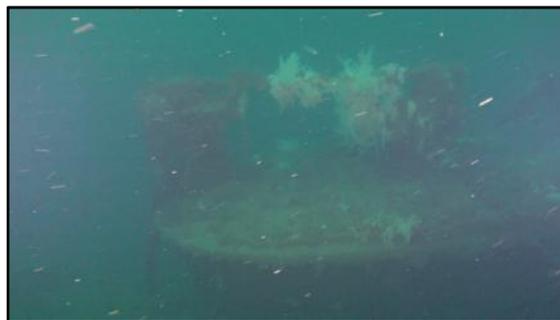
Figure 8 First view of AE2 fin

The ROV completed an external survey; good imagery was obtained and no major changes to AE2's appearance from the 2007 and 2013 surveys were noted. A diving medical emergency evacuation exercise was held, followed by a dive to clear away debris from around the hatch to avoid this entering the submarine during future serials.

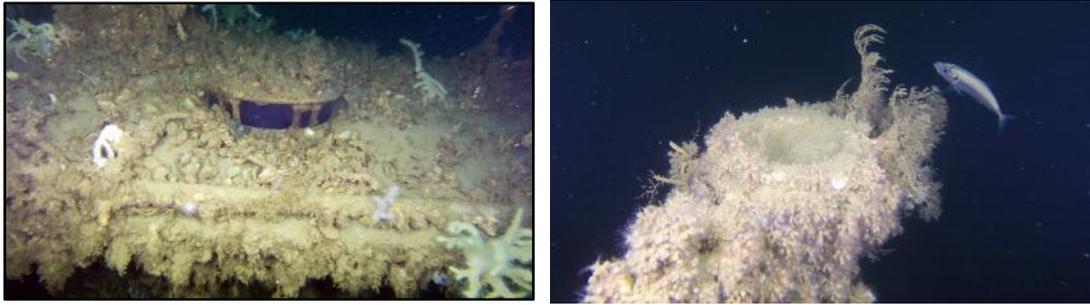
Figure 9 Conning Tower Hatch on first approach and forward periscope pedestal

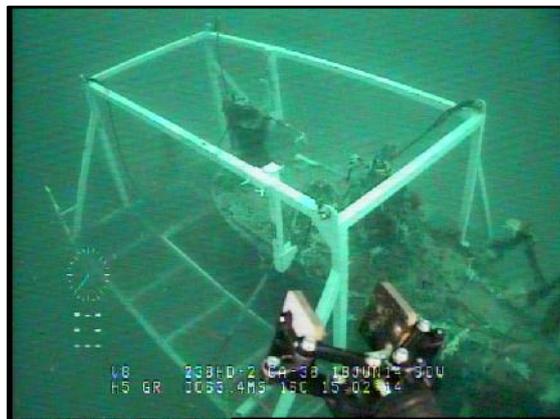
Figure 10 DSP in position. Taken on final flyover, shows CP connections in place with ROV grabber in foreground.

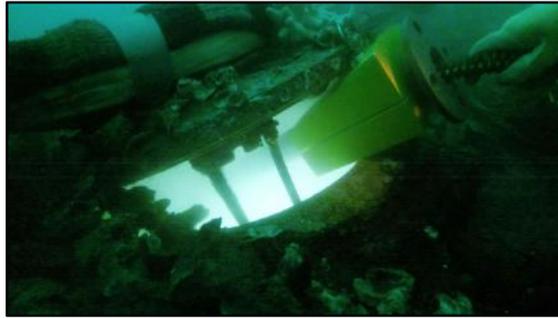
20. Wednesday 11 Jun 14. The stirrups were cut through and the hatch opened 3cm by hand, enabling the drop camera to be inserted during the second dive serial. Good images were recorded in the control room however visibility in the conning tower was poor due to the disturbance caused by the cutting and insertion. The drop camera was left inside the SM overnight in the hope of better visibility in the morning.

Figure 11 Drop camera illumination showing remaining hatch stirrup in place

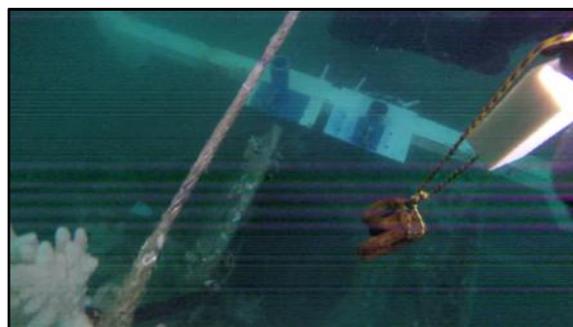
During the final dive for the day the hatch was opened to the near upright angle of 85 degrees using a chain block and secured in this position. A build-up of silt, shells and concretion obstructed further movement. This opening proved adequate to insert the ROV, avoiding the need to cut the hatch away. It is a testament to the submarine's designers, the ship builders and the Engine Room Artificer responsible for the maintenance of equipment outside the pressure hull adherence to the maintenance routines that the hatch bearings operated correctly after 99 years on the seabed!

Figure 13 ROV being inserted into open hatch. Shows instrument mount in place and ROV weights

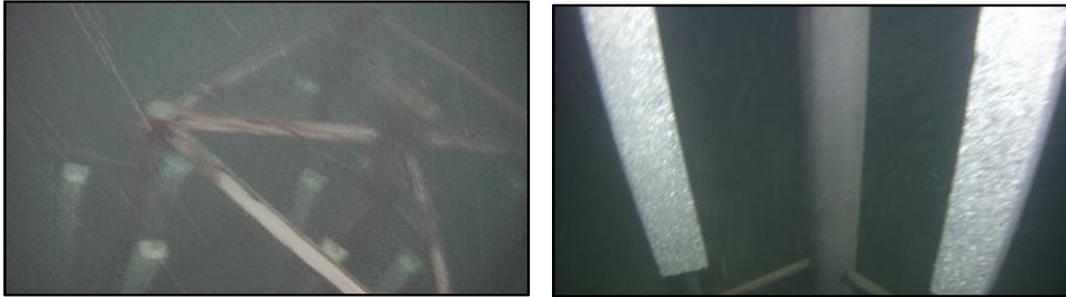
Figure 14 Anode pod in position. Same pod after 48hour connection showing depletion initiation has taken place.

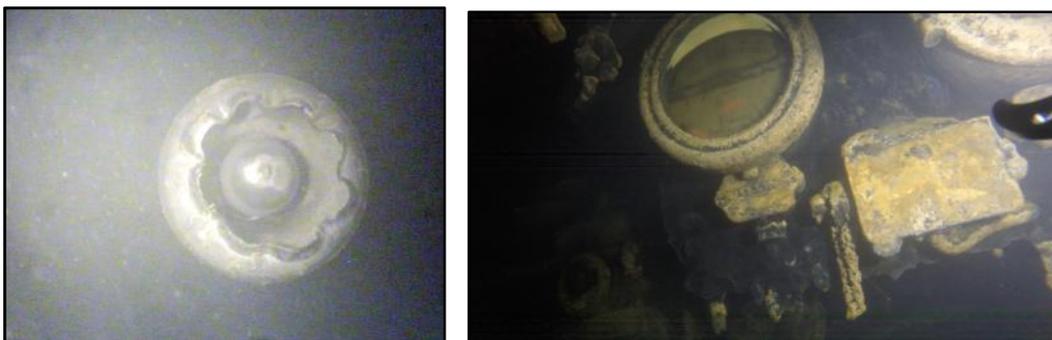
Figure 17 Tuesday's shots of the day; Captain Stoker's desk light and the Control Room Log

Images have been recorded from the Control Room through the wardroom, to the fore-ends and back taking in many equipments, artifacts and curiosities providing an unprecedented insight into early submarine construction and operation. Curiously only fragments of the spokes of the steering wheel, fore and after planes control wheels can be discerned, presumably these have

corroded away; providing a conundrum for our corrosion team. Among the many images, most memorable were the wooden wardroom furniture, the fluted light shade over the Captain's desk and the port decanter that sits intact on his desk.

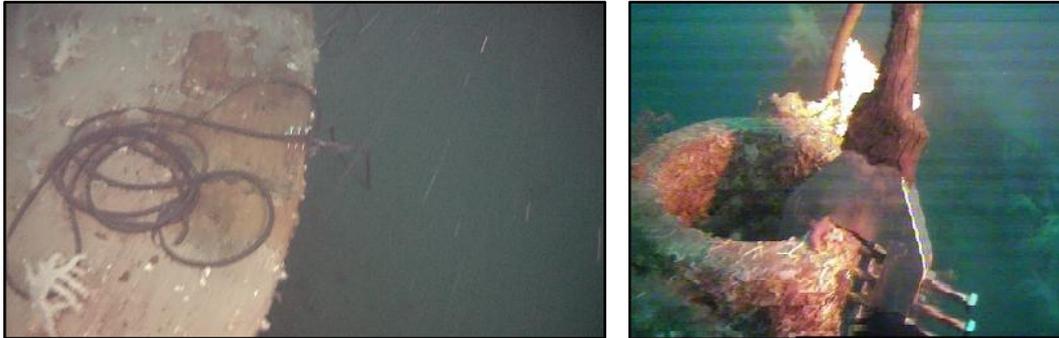
Figure 18 After CP connection to port hydroplane. Midships CP connection to periscope pedestal

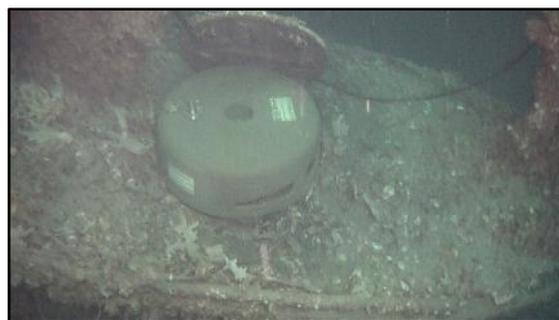
Figure 19 Hatch closure (Top Hat) in place, DSP removed. Anode connection cable visible
