# **An update to the Summary of the Risk to future operations Associated with the Torpedo remaining aboard HMAS AE2**

**By Capt Roger Turner BSc CEng FIMarEST RN**

**20 December 2007**

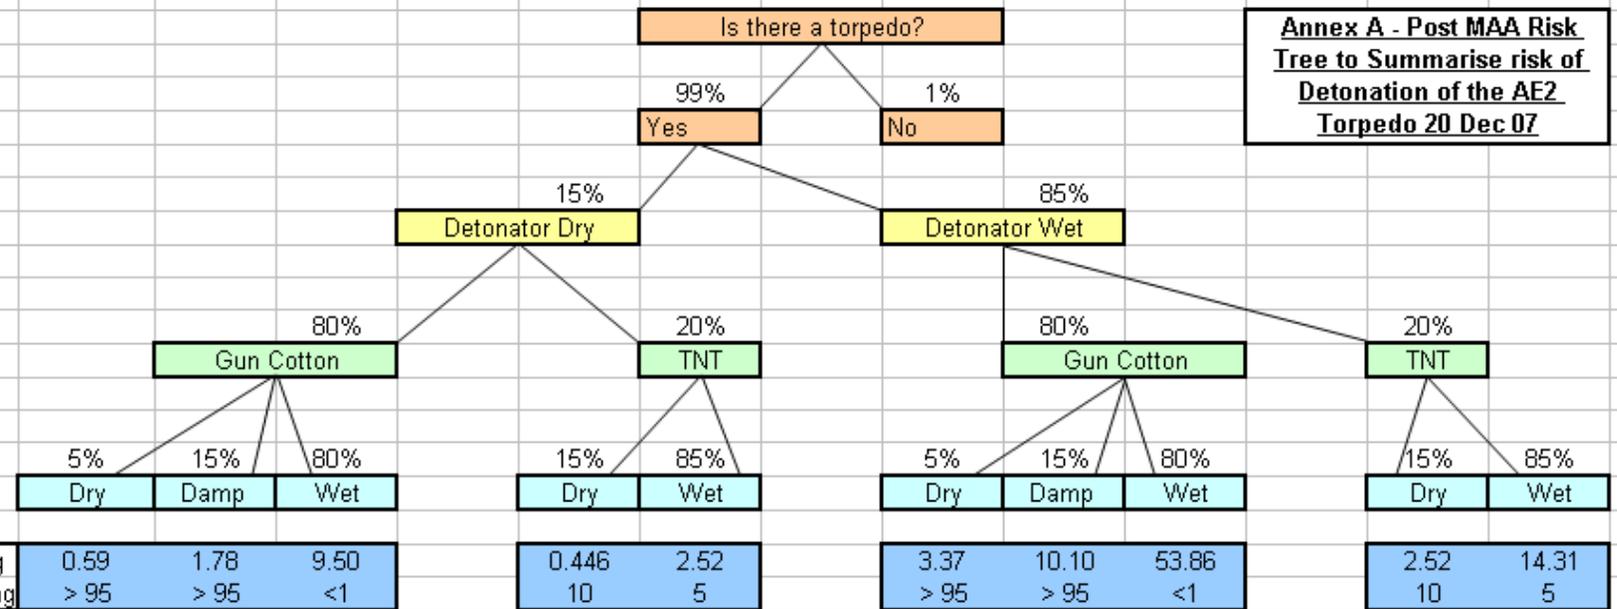
**Annex A - Post MAA Risk Tree to Summarise risk of Detonation of the AE2 Torpedo 20 Dec 07**

That argument can be quantified using the risk tree developed prior to the MAA. The probabilities assigned in this exercise are somewhat arbitrary and very much open to discussion. However, amending the wet/dry probabilities by an order of magnitude leads to a risk conclusion as shown in Attachment A. This demonstrates that the probability of an unplanned detonation has risen from 2% to 16%. Admittedly there is considerable supposition involved in reaching this conclusion but it serves to reinforce the previous position that:

The possibility of occurrence of a low probability, high consequence event cannot be ignored.

Summary	Chance of Occurring	16	3	17	63	1
	Chance of Detonating	> 95	10	5	<1	0
