Project Silent Anzac
Maritime Archaeological Assessment 2014
Interim Report

1. Project Silent Anzac is being undertaken by the AE2 Commemorative Foundation (AE2CF) Ltd, established by the Submarine Institute of Australia to protect, preserve and tell the story of the World War I Australian submarine, HMAS AE2.

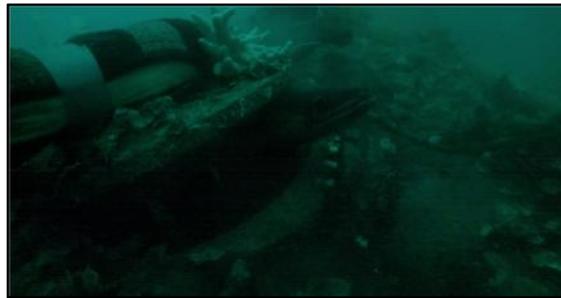
Figure 12 Bunts the conger eel emerges

During the final dive for the day the hatch was opened to the near upright angle of 85 degrees using a chain block and secured in this position. A build-up of silt, shells and concretion obstructed further movement. This opening proved adequate to insert the ROV, avoiding the need to cut the hatch away. It is a testament to the submarine's designers, the ship builders and the Engine Room Artificer responsible for the maintenance of equipment outside the pressure hull adherence to the maintenance routines that the hatch bearings operated correctly after 99 years on the seabed!
